Case report**Retrieval of Separated Instruments: A Case Series Part I**

Abstract: Separation of endodontic instrument within the canal is a challenge even for the most astute and experienced clinician. The first part of this paper series highlights the etiology of separated endodontic instruments with a case report illustrating one of the techniques for removal.

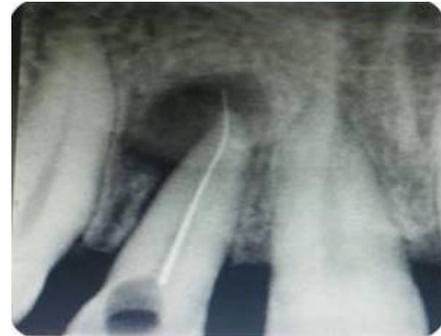
A 24 year old female patient was referred to the department of Conservative dentistry and Endodontics with a complaint of pain in upper tooth following endodontic treatment. Clinical examination revealed access opening done elsewhere in maxillary left lateral incisor. IOPA X Ray showed separated instrument in 22 pushed beyond the apex with peri apical radiolucency (Fig 1).

Figure 1: Pre Op IOPA showing broken file

The patient was informed about the situation and was given the choice for retrieval of the separated instrument or surgery or extraction.

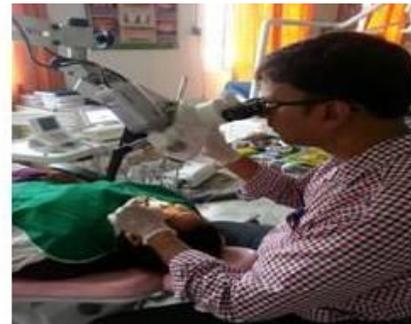
As it was a front tooth she first opted for retrieval. The instrument was visualized with the help of Operating Microscope (Fig. 2 and 3).

Figure 2: Operating Microscope

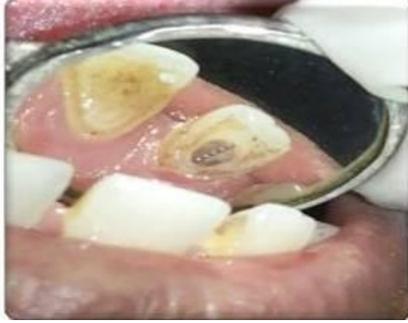
Figure 3: retrieved file

Retrieval was successfully accomplished with Pro Ultra ultrasonic endodontic tips (Fig 4) activated with EMS Piezo electric generator at medium power setting. (Fig 5). The canal was then prepared and obturated at a later appointment.

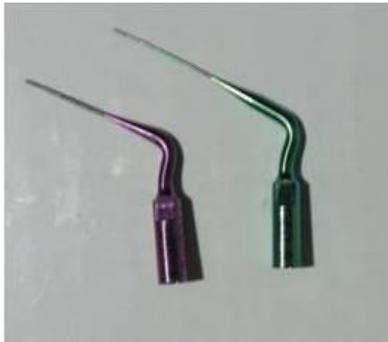
Figure 4: Pro Ultra Tips

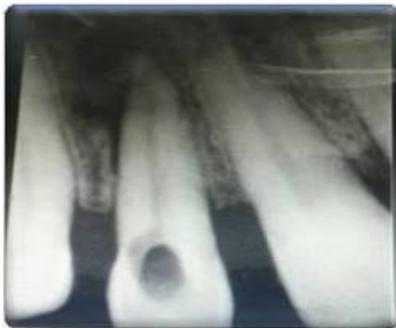
Figure 5: post retrieval IOPA
