Case Report

Mandibular Denture Repair with Metal Reinforced Orthodontic Wire: A Case Report

Banerjea A, Sangur R, Mahajan T, Shaw E

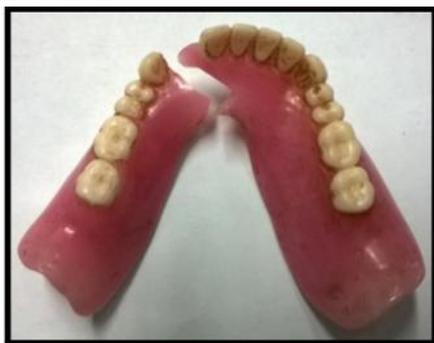
A 48 year old male patient reported to Department of Prosthodontics with a fractured mandibular denture (Fig. 1) and wanted repair of the same immediately. Treatment planned for the patient was to use the orthodontic wire to reinforce and repair the denture.

Figure 1: Fractured Mandibular Denture

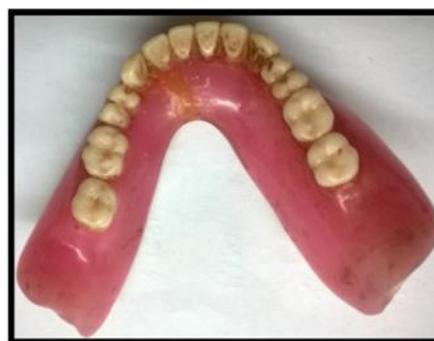
Figure 2: Sticky wax and glue used to assemble denture

1. The fractured mandibular denture was assembled as close as possible with the help of sticky wax and glue (Fig. 2).

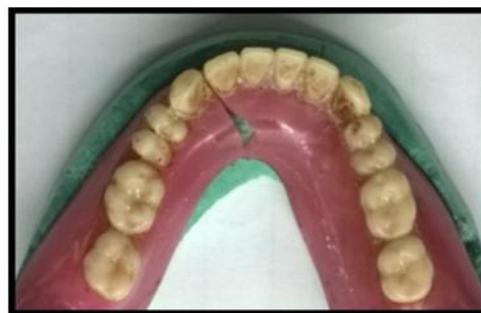
Figure 3: Cast Poured

2. Separating media was applied on the intaglio surface of the denture so that it could be easily removed from the cast (Fig. 3).

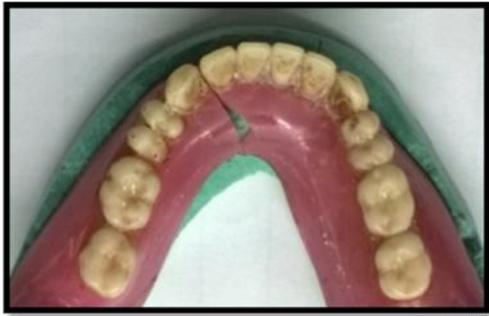
Figure 4: Fractured dentures replaced on the cast

3. The denture was removed from the cast. The denture was disassembled from the fractured area and replaced on the cast once again (Fig. 4).

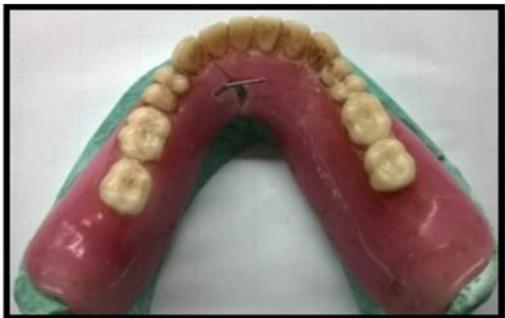
Figure 5: Use of an orthodontic wire

4. A groove approximately 5 mm wide was made in the lingual surface of the mandibular denture. An orthodontic wire was placed in the groove. The wire is used for better strength to prevent repeated fractures (Fig.5).

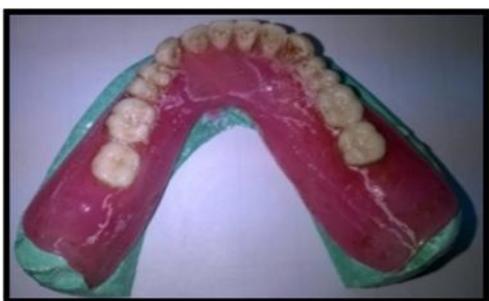
Figure 6: Use of self cure acrylic over the orthodontic wire.

5. Self cure acrylic powder and monomer was used to cover the wire and cover the fractured area (Fig. 6).

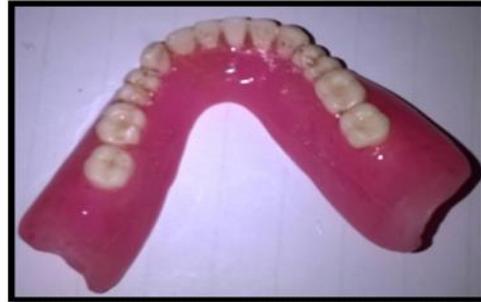
Figure 7: Finished and Polished Denture

6. The denture was finished, polished and delivered to the patient (Fig. 7). Denture insertion was done strictly following the denture insertion protocols as well as post insertion instructions given to the patient. The patient was reviewed 24 hours post insertion and examined as well as patient opinion recorded. Recall visit were also

done after 1 week intervals and the denture is inspected thoroughly for fracture lines. No evidence of craze lines is evident and denture was functioning well under the occlusal loads even after six months recall visits.
